Subject: MW Manufacturing Site - Trip Report

T R I P R E P O R T

MW MANUFACTURING SITE
DANVILLE, MONTOUR CO., PA

TDD No. 9510-038
EPA CONTRACT No. 68-S5-3002

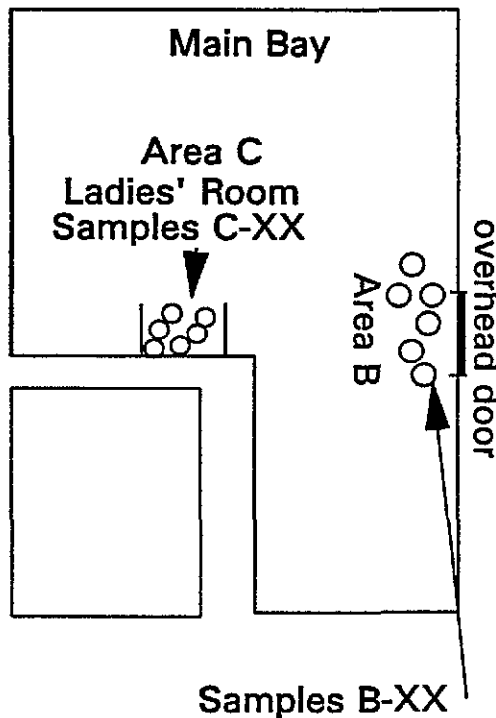
Figure 2.

Sampling conducted in areas b,c and s.
